# **Trombe Walls in Low-Energy Buildings: Practical Experiences**

P. Torcellini and S. Pless

*To be presented at the World Renewable Energy Congress VIII and Expo  
Denver, Colorado  
August 29–September 3, 2004*

Paul Torcellini and Shanti Pless  
National Renewable Energy Laboratory

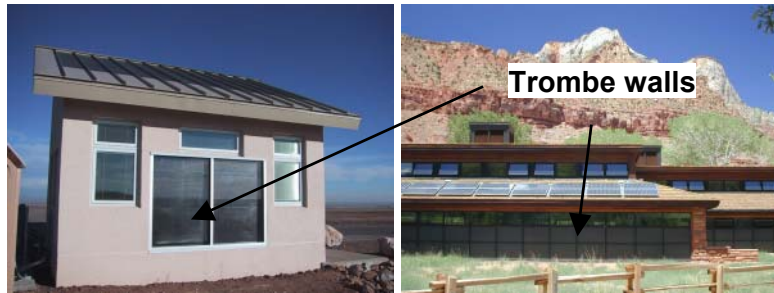
**Figure 1. a) NREL SEB, b) Zion Visitor Center**

Figure 1 shows the Trombe wall locations in the NREL SEB (a), and the Zion Visitor Center (b).

These Trombe wall design concepts were applied to the low-energy design of the Visitor Center at Zion National Park in Utah and to NREL's Wind Site SEB in Colorado.

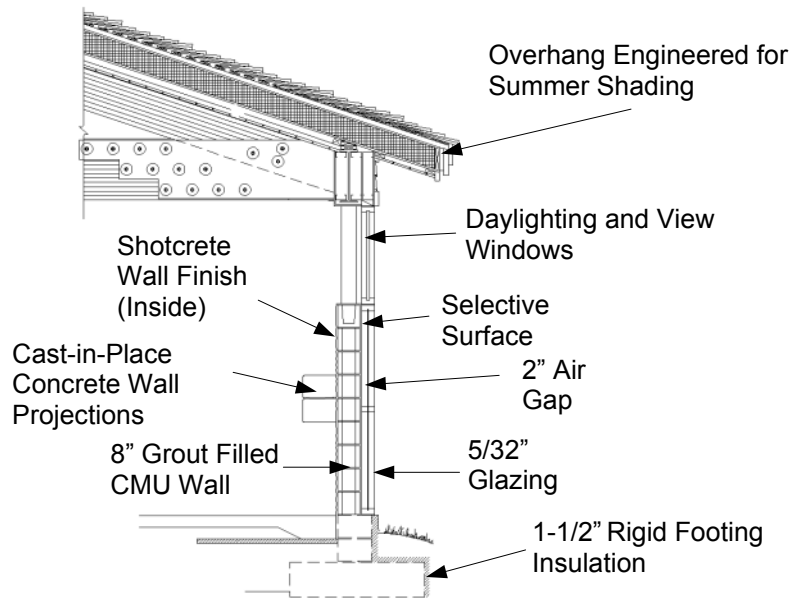
**Figure 2. Cross-section details of Zion Trombe wall**

The Visitor Center Trombe wall design details are shown in the cross section in Figure 2. The 6-ft-high (1.8-m) Trombe wall (740-ft<sup>2</sup> total area (68.7-m<sup>2</sup>) is located on the entire length of south-facing walls of the Visitor Center. The wall is 44% of the total south facing wall area. The Trombe wall is 8-in (20-cm) grout-filled concrete masonry units (CMU) with an R-value of 2.5 hr·ft<sup>2</sup>·°F/Btu (0.4 K·m<sup>2</sup>/W). The other walls are 6-in (15-cm) framed walls with an R-value of R-16 hr·ft<sup>2</sup>·°F/Btu (2.8 K·m<sup>2</sup>/W). The Trombe wall has a single piece of high transmittance patterned glass installed on a thermally broken storefront system.

The performance of Trombe walls is diminished if the wall interior is not open to the interior zones. Based on previous experiences with Trombe walls (Balcomb 1998), the heat delivered by a Trombe wall in a residence was reduced by over 40% because kitchen cabinets were placed on the interior of the wall. The wall design at Zion includes cast-in-place concrete projections attached to the interior of the wall. These projections were included to ensure bookshelves were not placed against the Trombe wall.

The interior surface of the Zion Trombe wall was selected to maximize the heat transfer to the space. Some interior surfacing materials, such as drywall, can reduce the heat delivered by Trombe walls due to nonconductive air gaps in between the concrete wall and the interior surface (Balcomb 1998). A shotcrete wall finish was specified to provide a more continuous conductivity throughout the wall.

During the construction process, the filling of the CMU wall was monitored to ensure the concrete block cores were completely filled, which provides a consistent conductivity through the wall. The placement of the footing insulation was also verified during the construction process to ensure proper installation. The location of this insulation is critical, as Trombe wall performance can be diminished due to three-dimensional heat

transfer to the ground. By thermally decoupling the footings from the ground with insulation, unnecessary heat loss is avoided and more heat from the Trombe wall is supplied to the building.

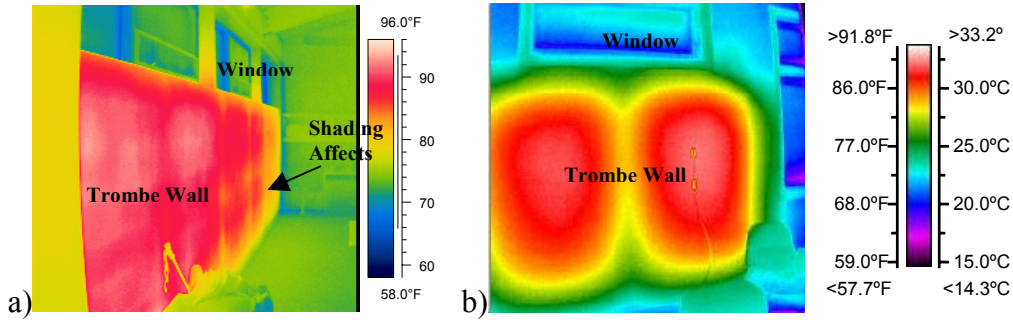
**Figure 3. Infrared pictures of a) Zion Trombe wall December 16, 8:30 p.m. and b) NREL SEB Trombe Wall January 21, 8:00 p.m.**

Figure 3 shows the thermal distribution of the Zion Trombe wall at 8:30 p.m. on December 16, 2000. The interior surface temperature is generally homogeneous, ranging from 90-96°F (32-36°C). The wall temperature typically peaks between 8-9 p.m. The reduced wall temperature at the far right section of Trombe wall is due to shading. The

building shades a portion of the Trombe wall in the afternoon, resulting in reduced interior temperatures.

The interior surface temperature of the SEB Trombe wall typically peaks at 120-130°F (49-54°C) at 3:30-4:00 p.m. during the heating season. The interior temperatures of the SEB wall are generally higher, but earlier in the day than the Zion wall. This difference is due to the 4-in (10-cm) SEB wall that releases the heat quicker than the 8-in (20-cm) Zion wall. During good solar days in the heating season, the Trombe wall typically provides all of the necessary heating throughout the afternoon and evening.

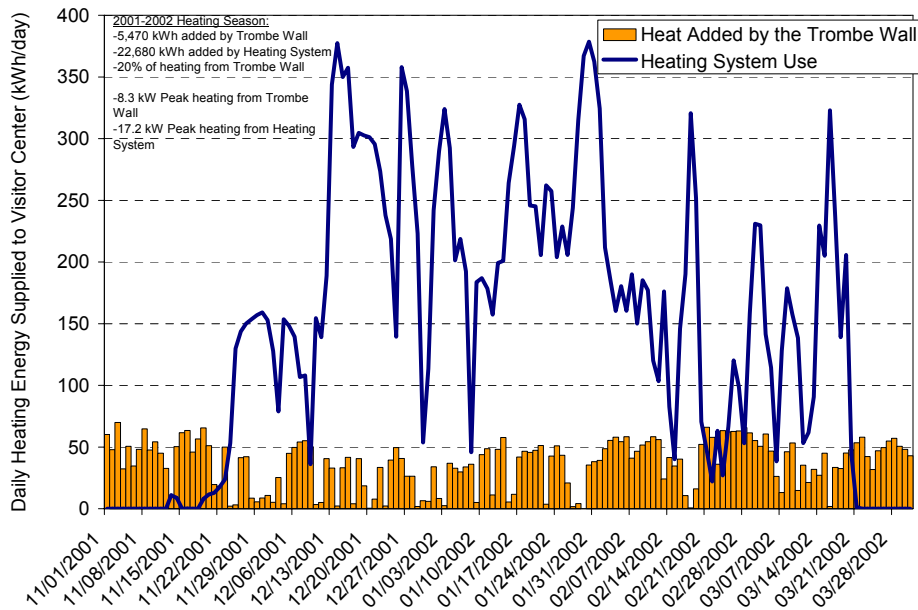
**Figure 4. Zion Visitor Center Trombe wall and heating system performance, 2001-2002 heating season**

The temperature gradient in the wall was measured during the 2001-2002 heating season. With internal temperature measurements, the Trombe wall energy supplied to the building was calculated based on published heat flux calculation methods (Balcomb 1980). The Visitor Center Trombe wall daily performance during the 2001-2002 heating season is shown in Figure 4. The electric radiant heating system used 22,680 kWh (81.6 GJ) over the year, with the Trombe wall contributing 20% of the total heating to the building. The Trombe wall imposed a heating load on the building for only two of the 151 days of the 2001-2002 heating season. For the other 149 heating days, the wall was a net positive. The peak heat flux through the wall was  $11.2 \text{ W/ft}^2$  ( $89 \text{ W/m}^2$ ), or 8.3 kW over the entire Trombe wall area. The average efficiency of the wall (defined as the heat delivered to the building divided by the total solar radiation incident on the exterior of the wall) was 13%.

The Trombe walls in both the Visitor Center and the SEB provide significant heating to the buildings. In the Visitor Center, 20% of the annual heating was supplied by the Trombe wall, and the SEB afternoon and evening heating loads are typically met by the Trombe wall. The annual net effect of the wall has to be considered when designing a Trombe wall, as the additional cooling loads can affect the cooling system performance.
